Project Preface

Quote 4 Drones Details

1. Introduction

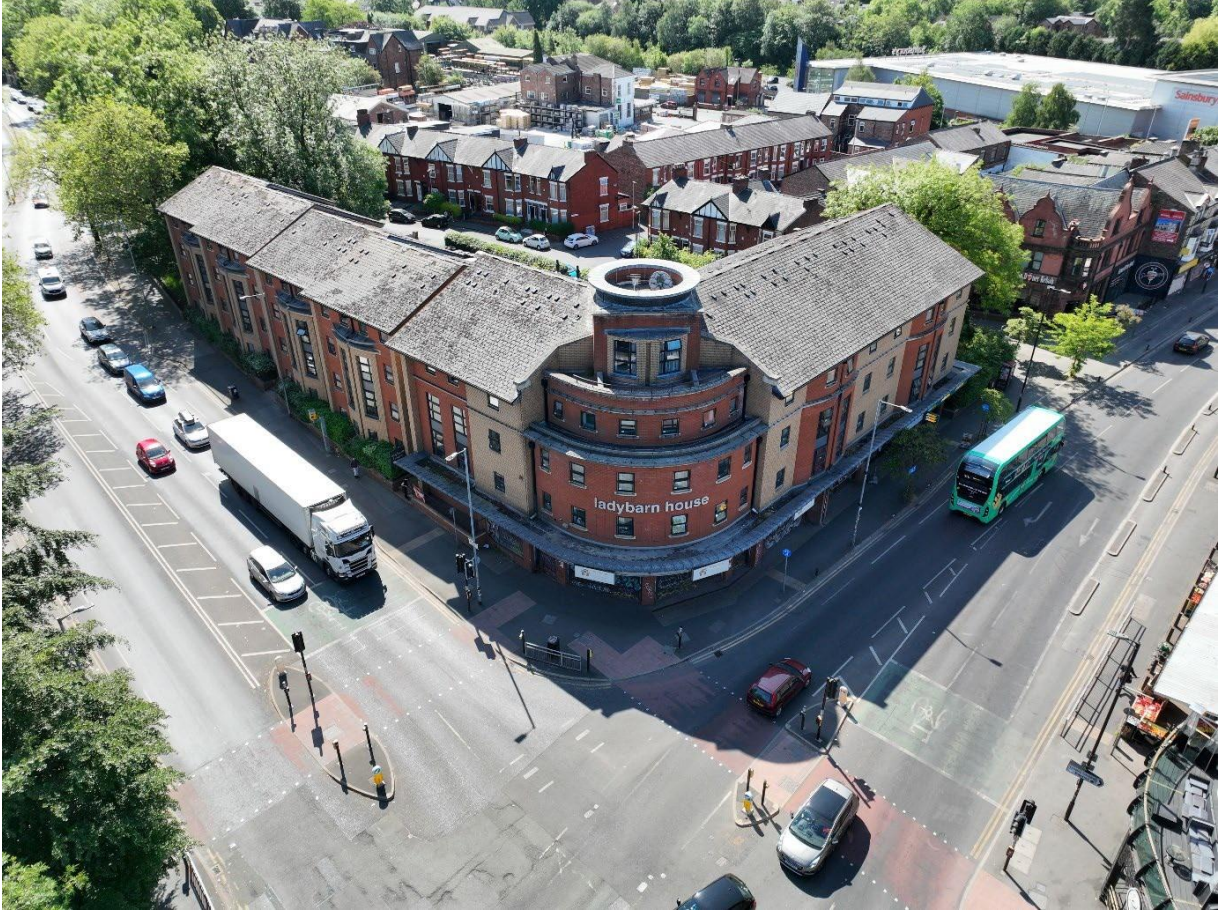
1. Identification photograph

General view of the building looking southeast.

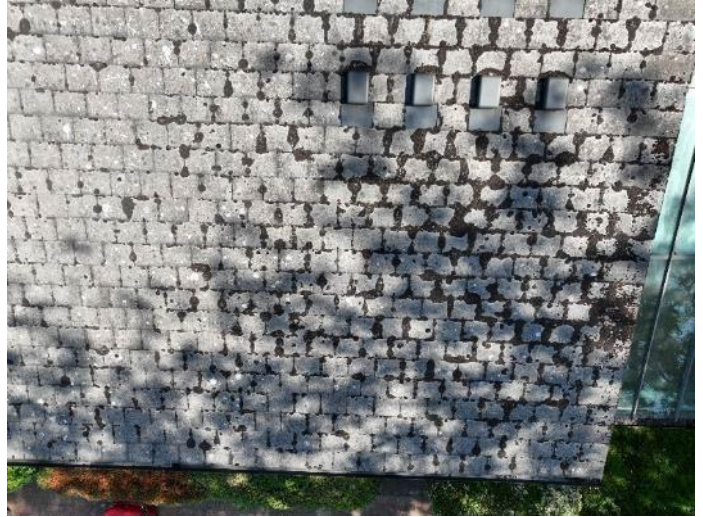
3

View showing vegetation growth to the roof coverings on the south facing pitch and to the top side of vent cowls.

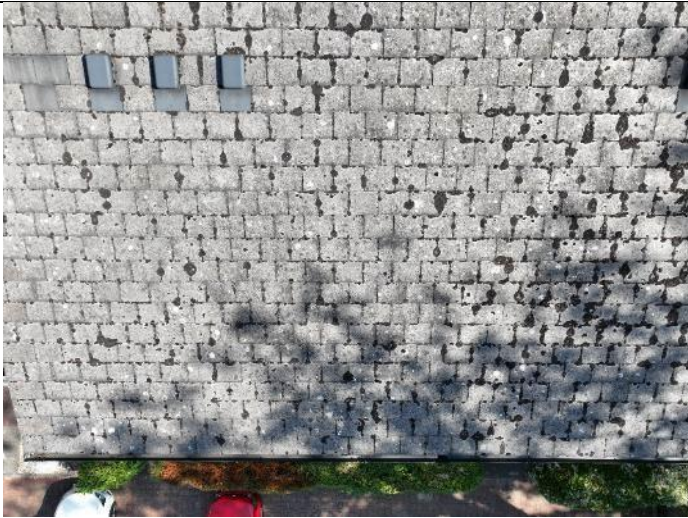
Item No.	Description	Photo
4	Further view showing vegetation growth to the roof coverings on the south facing pitch and to the top side of vent cowl.

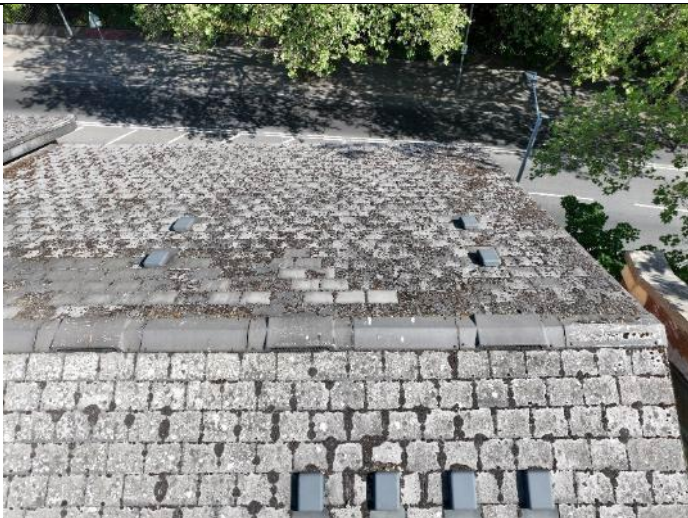
6	Further view of the north facing pitch showing vegetation growth to coverings.

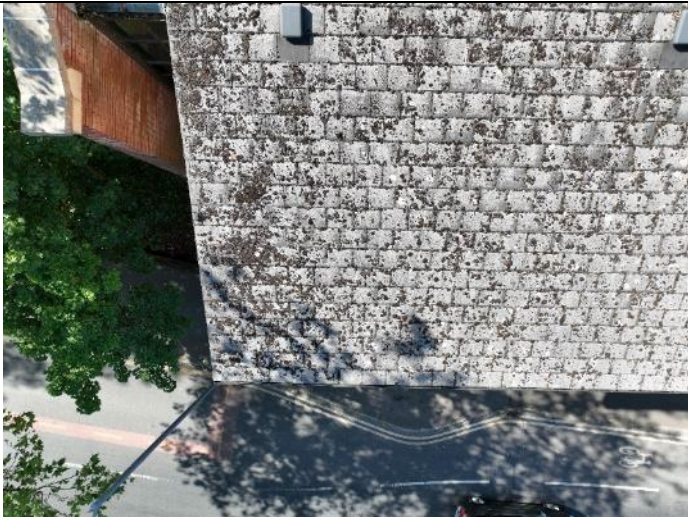
8	View showing vegetation growth to the roof coverings on the north facing pitch.

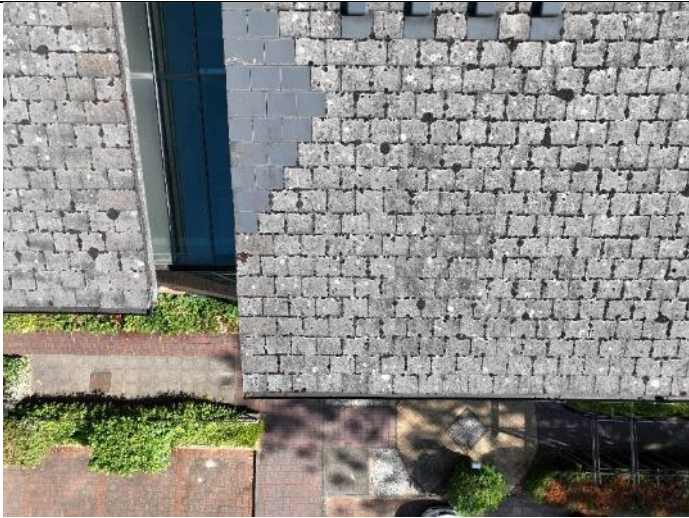
An area to the west, on the south pitch, adjacent to the glazed link has been recovered, whilst there are visible fixing holes to these replacement tiles there are no visible fixings and therefore these are presumed to be held in place with an adhesive. Two tiles immediately above this area have slipped, with one missing from the roof entirely. It is presumed that these were disturbed during the repairs and not properly secured. This has left a hole into the roof void, there is evidence of roofing felt beneath, which appears to be a bitumen type felt that can contain asbestos fibres. The felt is degraded and is not providing the secondary barrier to water penetration as designed.

Item No.	Description	Photo
13	View to section of replaced tiles.

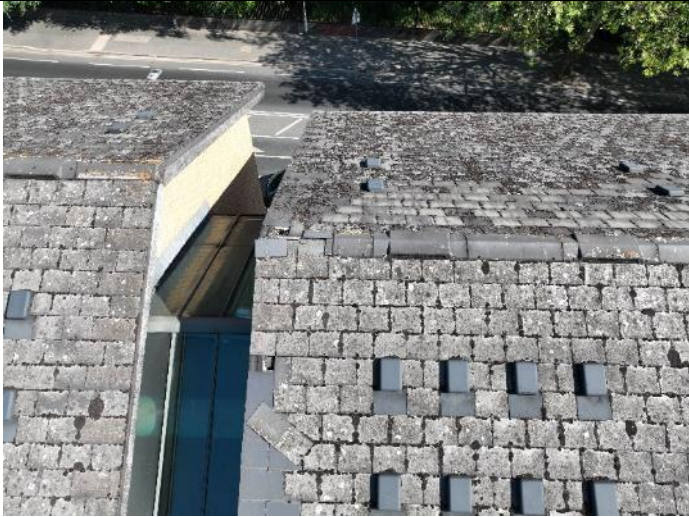
On the north pitch, one of the vent cowls is missing the cap to prevent water penetration. Opposing the slipped tiles mentioned on the south pitch, there are two missing tiles to the north. Again, the felt beneath is degraded and a hole for water penetration is present, the ridge tile above this area is also missing.

14	Slipped tile at the verge on south facing pitch and holes through to roof void on both pitches also section of ridge tile missing.

The tiles should be tested for asbestos content, following this we recommend patch repairing the slipped and missing tile areas and replacing the cracked and split ridge tiles.

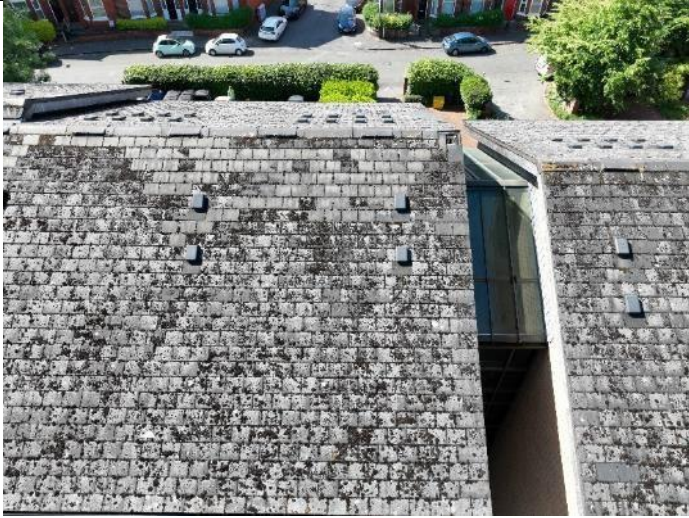
15	General view showing the glazed roof of the interlinking staircase, historic section of replaced tiles and general vegetation throughout and the missing ridge tile and hole to coverings.

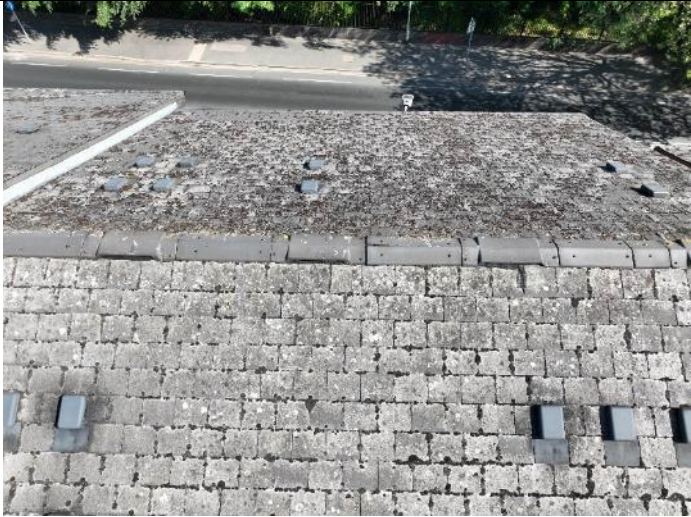
There does not appear to be any slipped tiles to this section. The ridge tiles have a lightning protection tab protruding from underneath, one of the ridge tiles has split down the apex to at least two thirds of its length. Whilst it is fixed in four locations and therefore may not present a hazard from falling debris in the near future, it is likely a location for water ingress. The adjacent vented ridge tile has loose insect mesh that needs reinstating to avoid an infestation within the roof void. Two of the ridge tiles appear to have either been originally fixed with only three fixings, or has one missing.

20	General view down the north facing pitch, note the loose insect mess to the right most ridge vent tile, also note the split ridge tile adjacent.

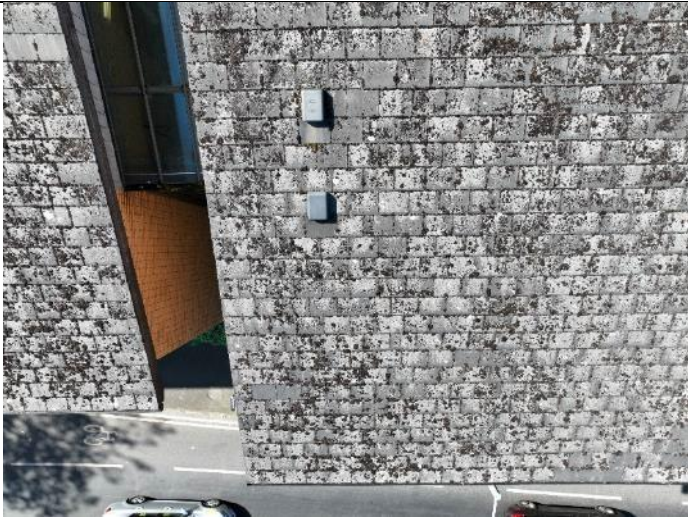
Item No.	Description	Photo
22	View of vegetation growth to coverings and solar degradation to vent cowls.

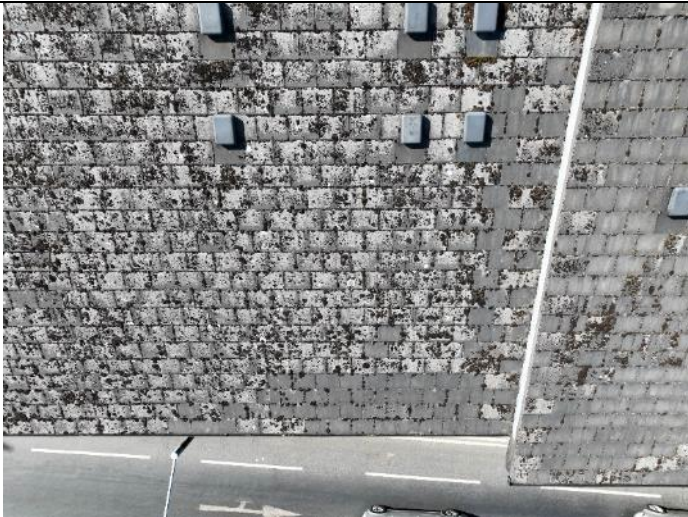
23	View of vegetation growth to coverings and solar degradation to vent cowls.

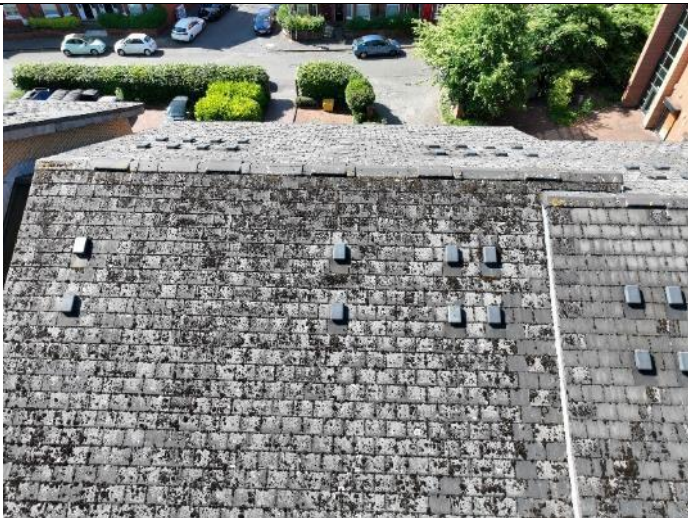
24	Further general view of the roof coverings and vegetation growth noting the location of the split ridge tile.

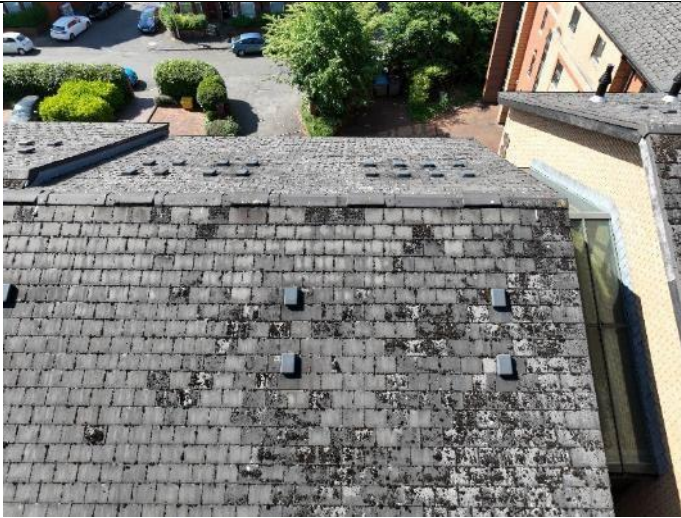
Item No.	Description	Photo
31	<p>Vegetation growth generally to the roof coverings and lightning strap evident below two ridge tiles. Also note the weathered barge boards to the adjacent roof section.</p>

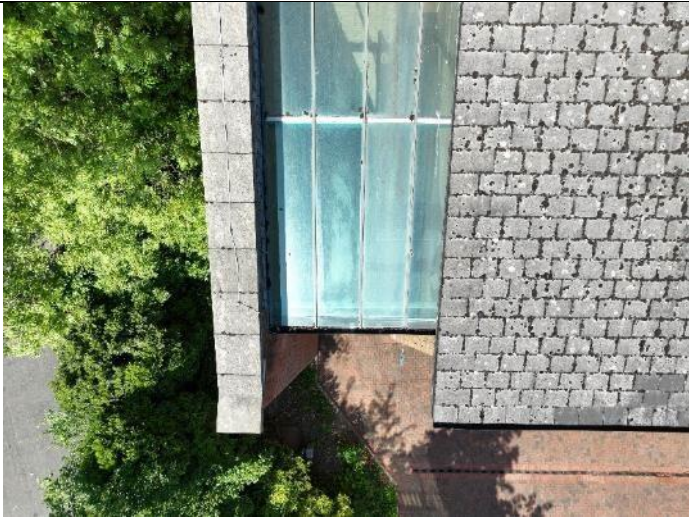
To the south end, the glazing over the stairwell is dirt stained, these are presumed to be single-glazed, therefore the staining is likely to be to both internal and external surfaces.

Item No.	Description	Photo
37	Staining to the glazing over the stairs at the south end.

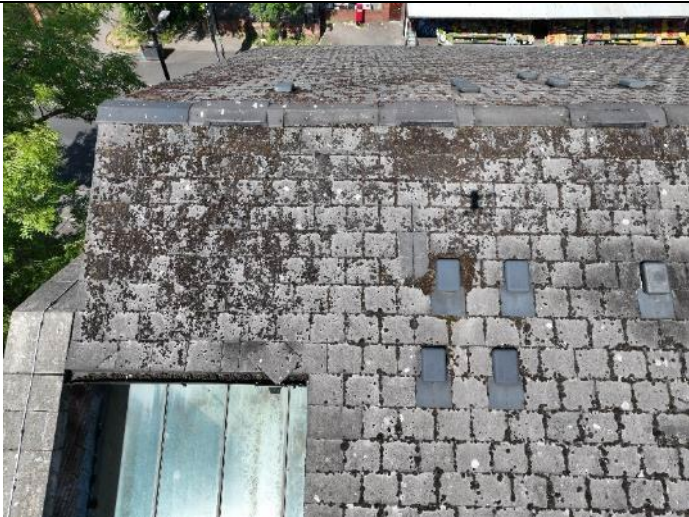
To the south end of the east pitch there are two slipped tiles and one above the glazed stairwell section is cracked.

38	Two or three slipped/missing tiles to the south end east pitch.

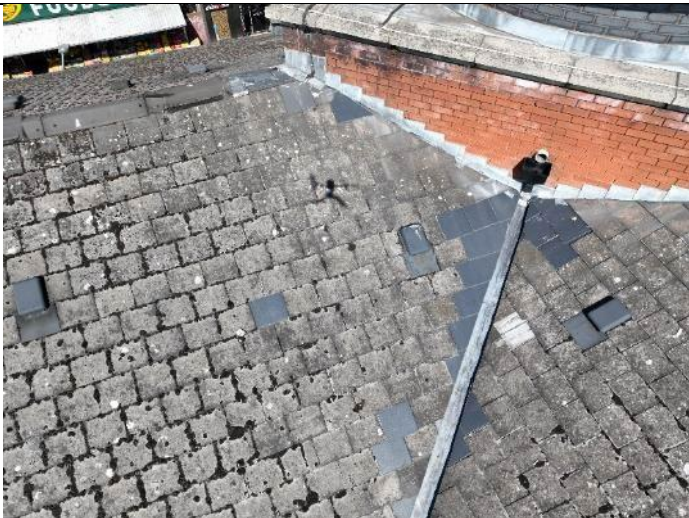
At the junction between the south and east pitches is a valley gutter presumed to be lined with lead. Adjacent to this, on both sides are new looking tiles, these have no visible fixings, or fixing holes, they are therefore presumed to be held in place with some form of adhesive. The number of replacement tiles increases towards the parapet wall of the penthouse projection, with a few of these appearing displaced.

The ridge tiles to the east wing appear intact and free from defects, however, there are five missing fixing caps to the ridge tiles of the south wing, one ridge tile adjacent to the penthouse projection has a flash band repair (which are typically temporary fixes). Four of the ridge tiles were noted to have potential splits along their apex.

39	Flashband repair to the ridge tile adjacent the parapet flashing. Replacement tiles with no visible fixings, some of which appear to have slipped.

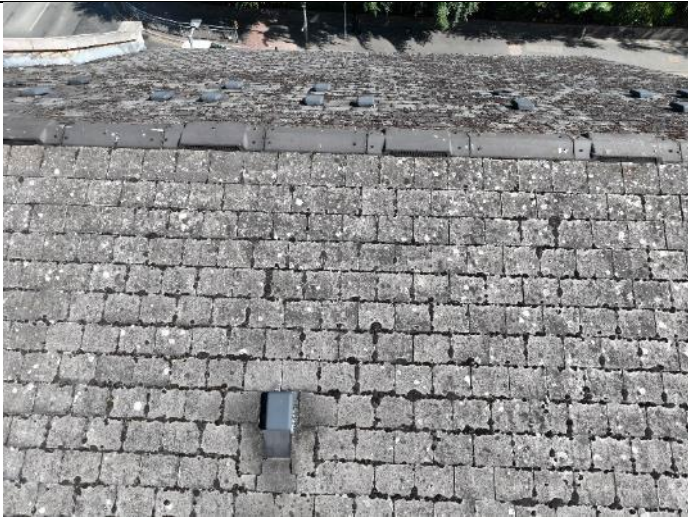
Item No.	Description	Photo
40	Slipped tiles either side of the vent cowl.

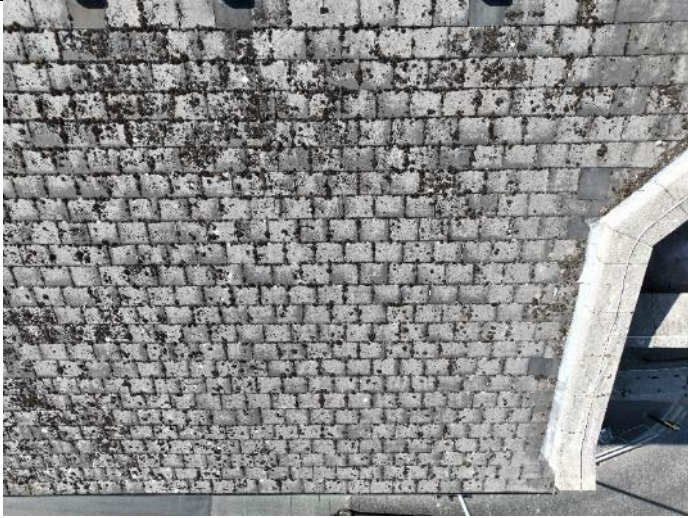
42	General vegetation growth throughout and slipped tile to right of the image.

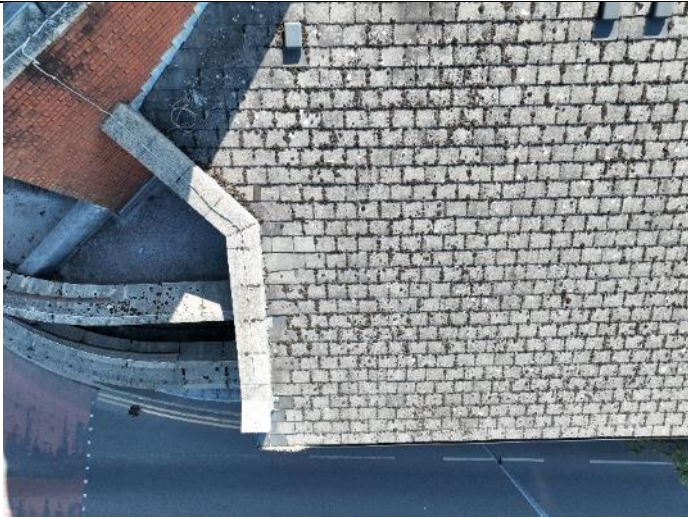
To the north facing pitch we note two missing caps to the vent cowls, a slipped tile adjacent to the parapet wall of the penthouse projection. A further slipped tile is present to the other side of the penthouse on the west pitch, with a further missing tile at the far south end and two further missing vent cowl caps.

Item No.	Description	Photo
43	Slipped tiles adjacent to the parapet structure and general vegetation growth throughout.

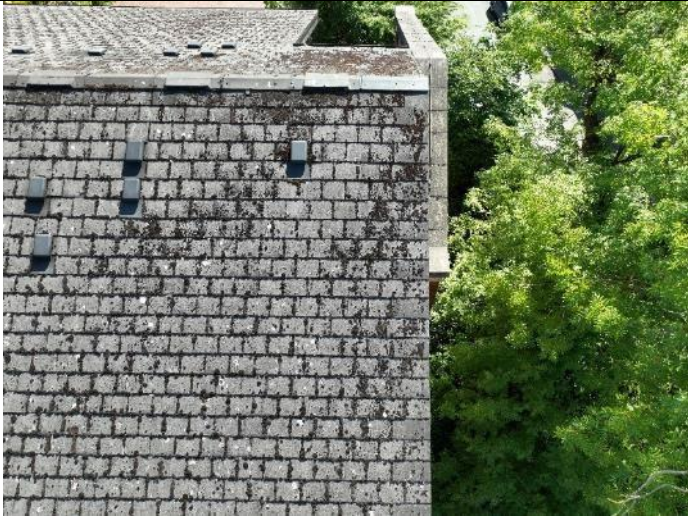
44	Missing tile to top right hand corner.

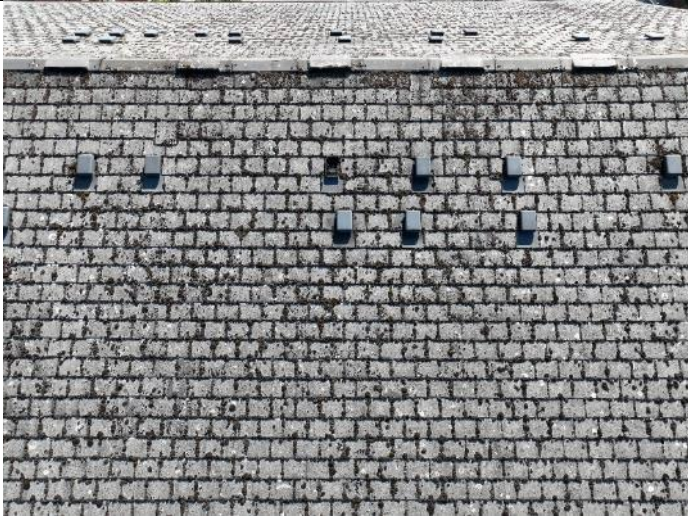
45	Missing vent cowl cap and vegetation growth throughout.

Missing vent cowl caps ought to be reinstated to prevent water ingress at these locations and lead flashings that are coming loose to the penthouse projection need re-attaching to prevent any water ingress.

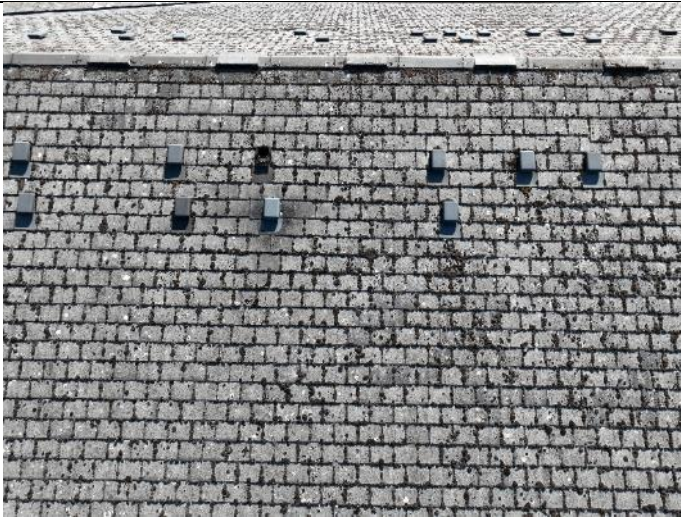
Item No.	Description	Photo
46	Missing vent cowl cap and vegetation growth throughout.

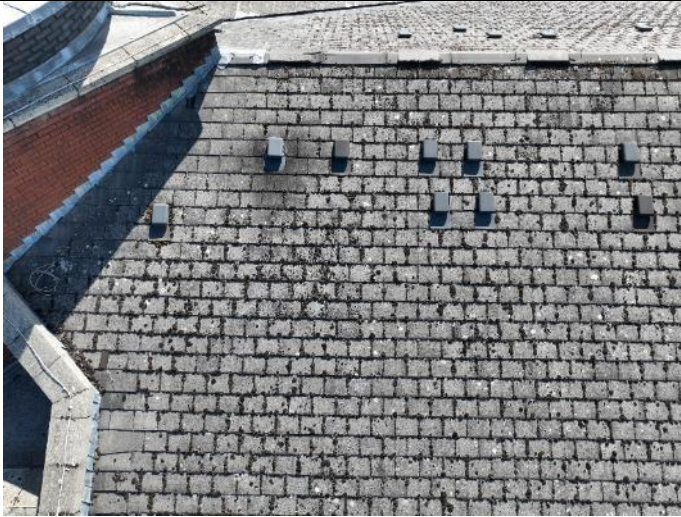
47	Further view of temporary repair to the ridge tile and vegetation growth to coverings.

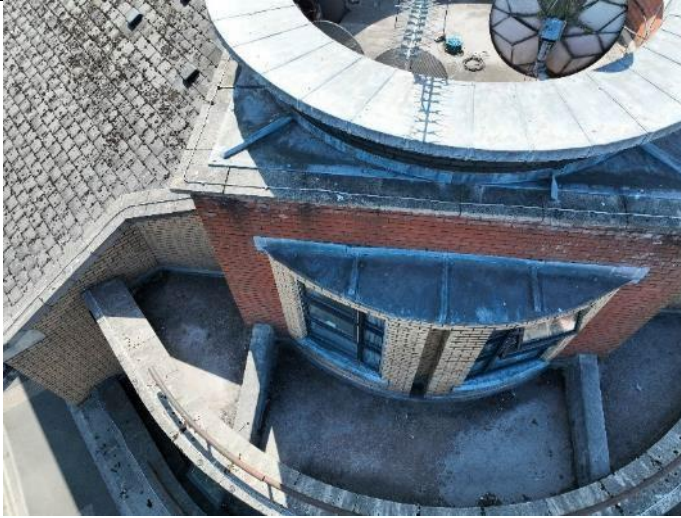
Lead is also used to provide protection to the penthouse bay window projection. In two locations the Lead was noted to be coming away from the brickwork and will require re-securing to prevent water ingress. Above this location to the round parapet structure lead was also noted to be coming away from the brickwork and will require resecuring.

48	Bay roof lead flashing loose above the outermost ridges and also loose to flashing of round section above.

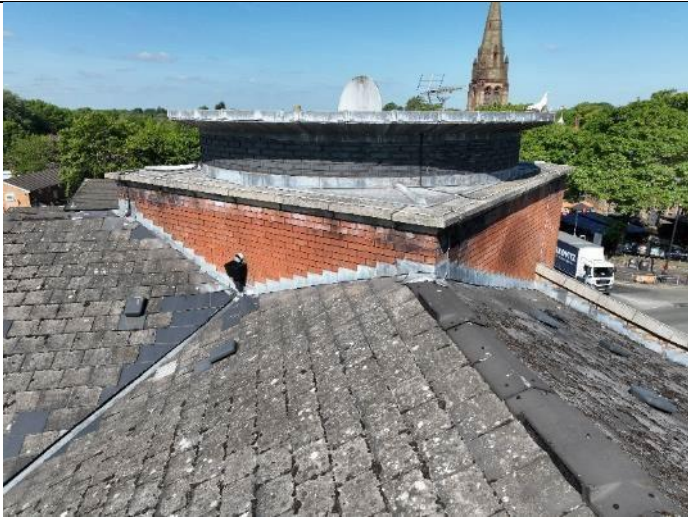
The parapet walls are red and buff brick to tie in with the main structure, there is staining at high level, considered to be from splash back run-off as there is no rainwater collection system in this area.

Item No.	Description	Photo
49	General view to the rear of the penthouse projection showing staining to brickwork.

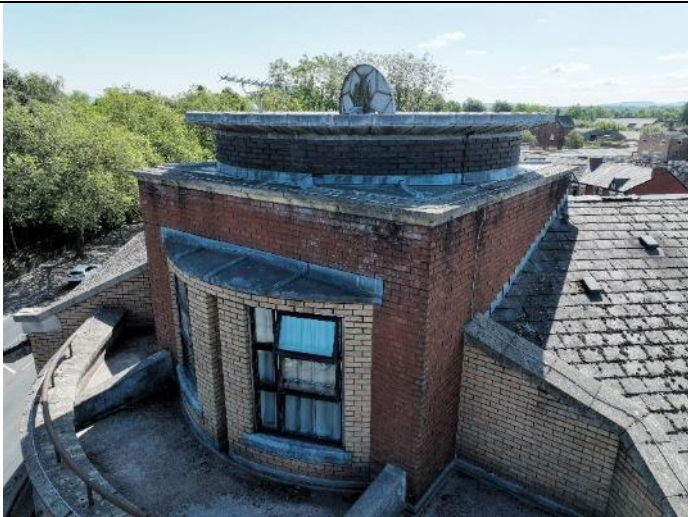
50	General view to the front of the penthouse projection showing staining to brickwork.

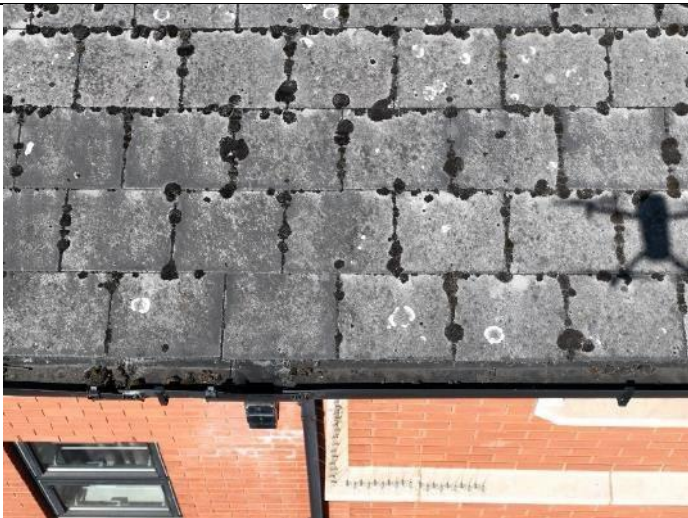
The guttering to the west pitch has minor debris within it and three sagging or poorly fixed joints were noted on the east facing pitch.

51	Close up of guttering showing the loose junction.

The three poor connections to the east pitch need to be properly fixed to the guttering.

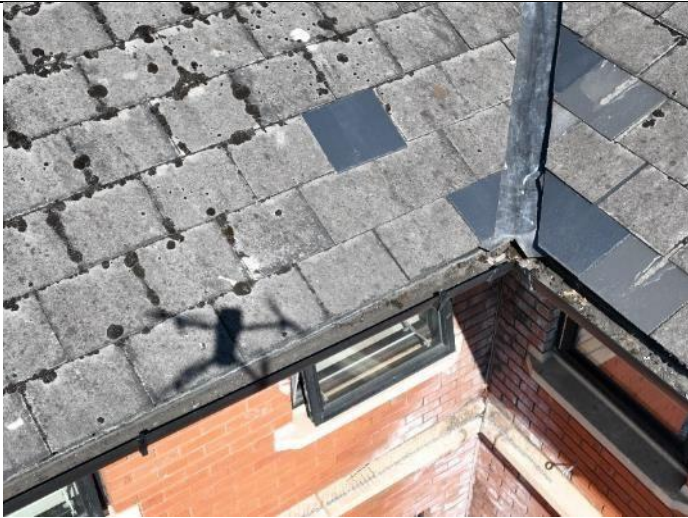
Item No.	Description	Photo
52	Poorly detailed end of the lead valley.

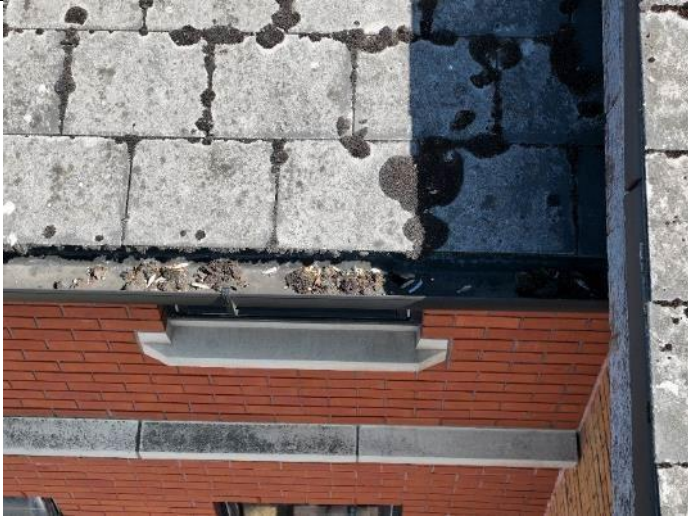
54	Debris to guttering.

The gutters throughout require cleaning, which may be done as a byproduct of the roof cleaning.

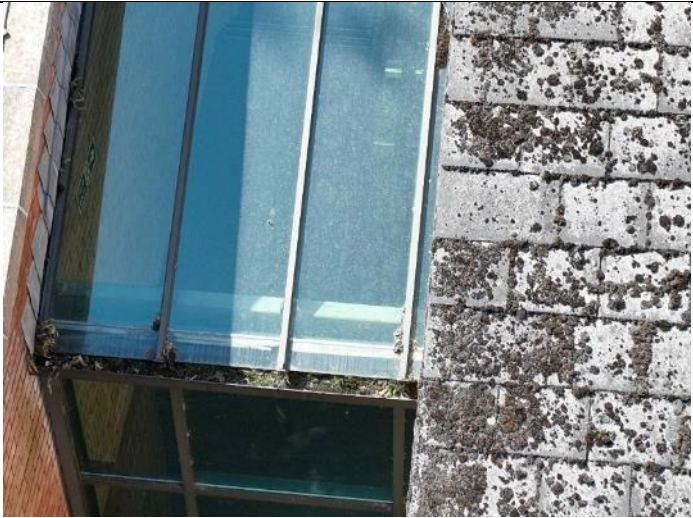
The gutters to the south and north pitch have minor debris within them, whilst those to the glazed section of the stairs are blocked with debris.

Item No.	Description	Photo
55	Blocked guttering with significant debris build up.

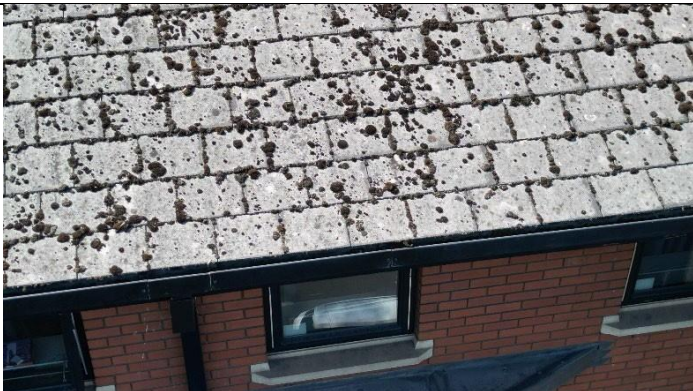
57	Minor debris to guttering.

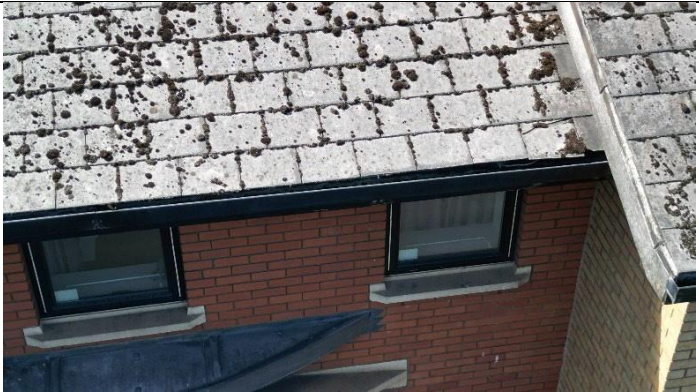
To the north of the building are small feature flat bay roof details covered with lead. The north pitch guttering discharges to the centre of these which in turn drain to a central hopper and a downpipe that splits the bay detail. There is general dirt staining and minor debris build up to the bay covering.

Item No.	Description	Photo
58	General dirt staining to the bay roof coverings.

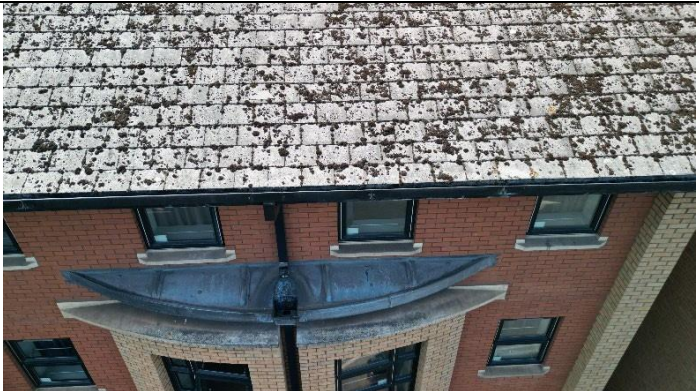
59	General staining throughout the bay roof and debris to the guttering above.

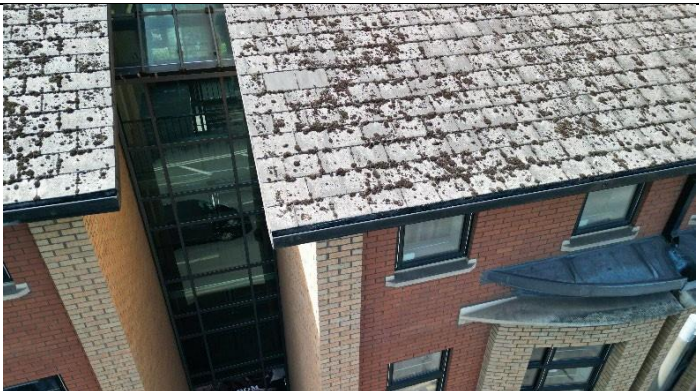
60	General staining throughout the bay roof and debris to the guttering above.

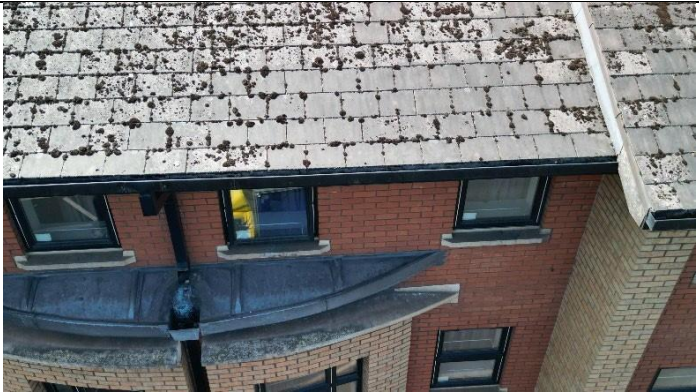
Item No.	Description	Photo
61	General staining throughout the bay roof and debris to the guttering above.

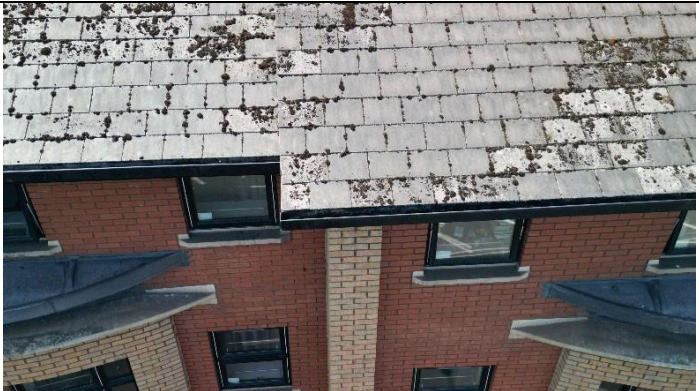
62	Minor debris to gutters.

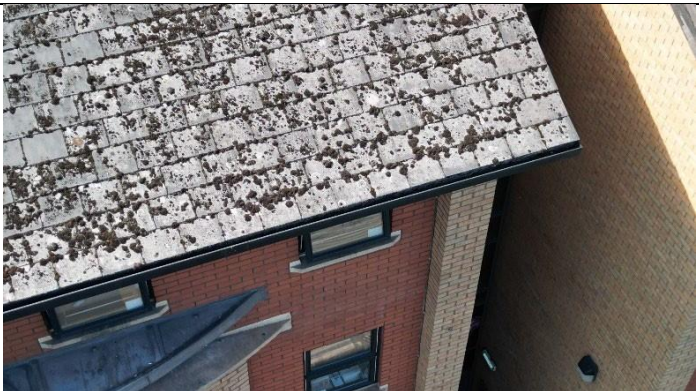
63	Further minor debris to the guttering.

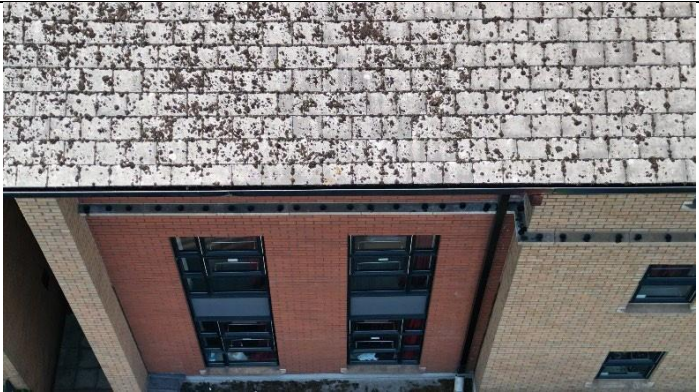
Item No.	Description	Photo
64	View showing anti bird fittings to string course and debris to canopy coverings below.

We further recommend clearing all the debris from the ground floor canopy to prevent further deterioration of the coverings.

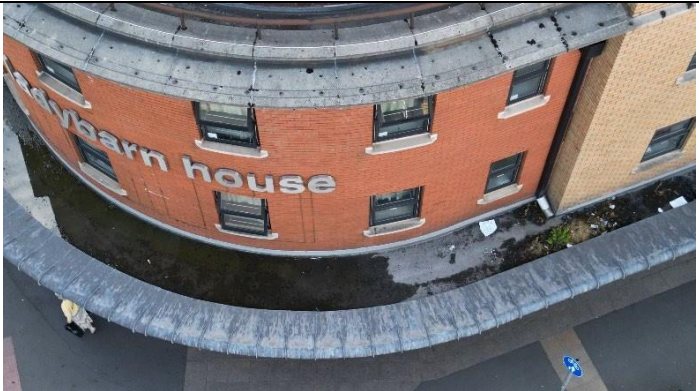
We note large areas of moss growth or moss debris from the main roof collecting on the canopy that will cause rainwater to back up and potentially overflow flashing depths and cause internal damage. Some of this is now providing soil for larger plants to start growing and will need clearing away.

65	Standing water, debris and vegetation growth to the canopy coverings and minor vegetation growth to the balcony coping stones.

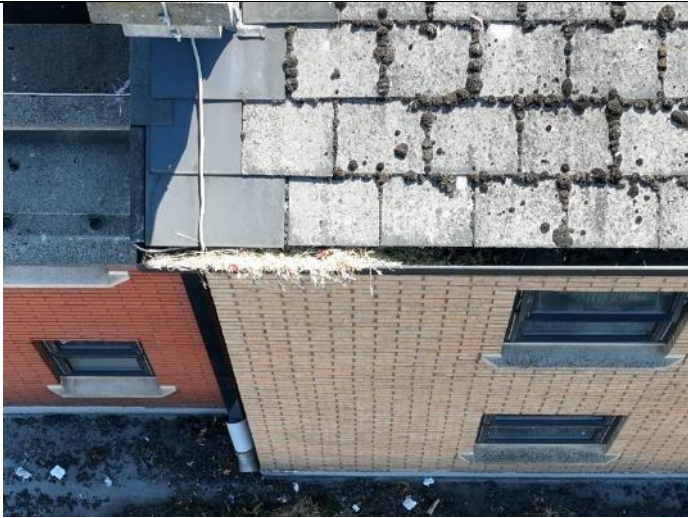
Item No.	Description	Photo
67	Vegetation growth to the guttering adjacent to downpipe.

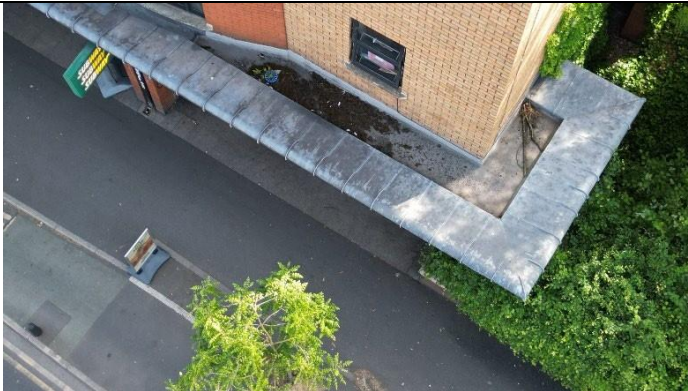
68	Vegetation debris to the canopy coverings.

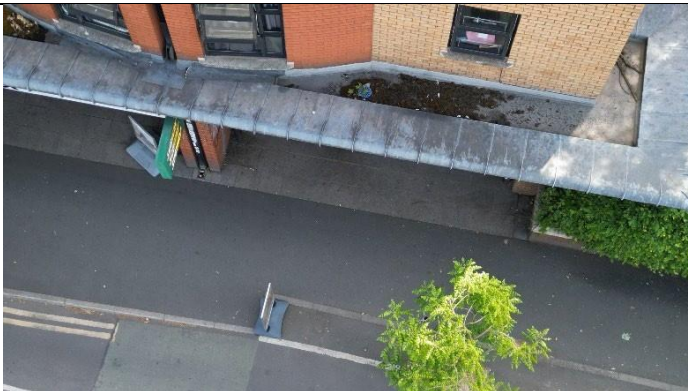
Where the curved bay walls meet the canopy we note possible patch repairs to the area below the window cills where flashings having been patched with flash-band. The one just to the north of the Subway sign has come away from the building and is laid partly across the canopy covering.

69	View of the loose flash-band to the window cill areas.

We would also recommend a close inspection of the canopy coverings, having cleared away the debris to assess for any damage and ascertain whether historical repairs were warranted and whether a better solution can be carried out.

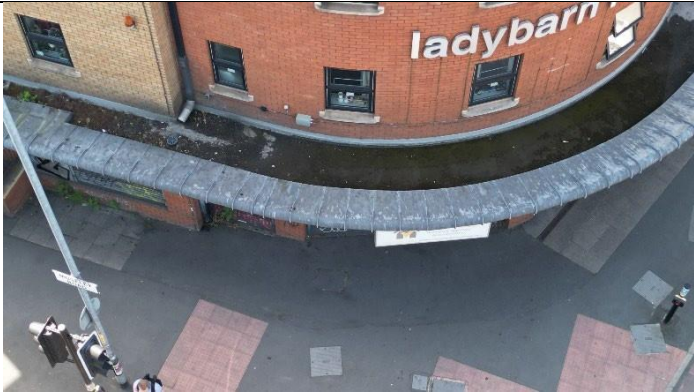
Item No.	Description	Photo
73	Standing water, debris and vegetation growth to the canopy coverings.
