Project Preface

Quote 4 Drones Details

1. Introduction

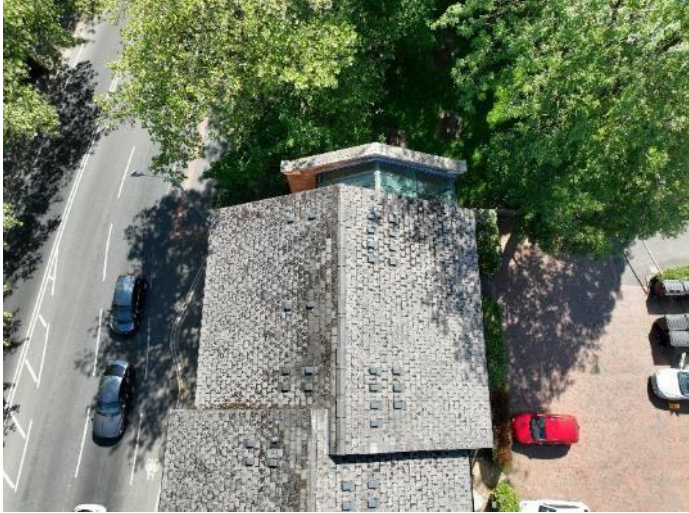
Item No.	Description	Photo
1	General view to roof section 1 at the east end of the building.

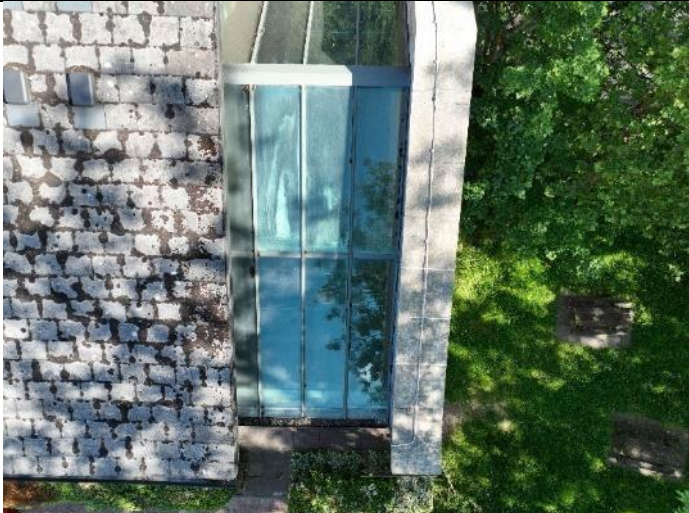
An aerial photograph showing a building with a grey stone roof. A glass-enclosed stairwell is visible on the right side of the building. The building is surrounded by green trees and a paved area with several cars parked.
2	View of the glazing over the stairwell, south side.

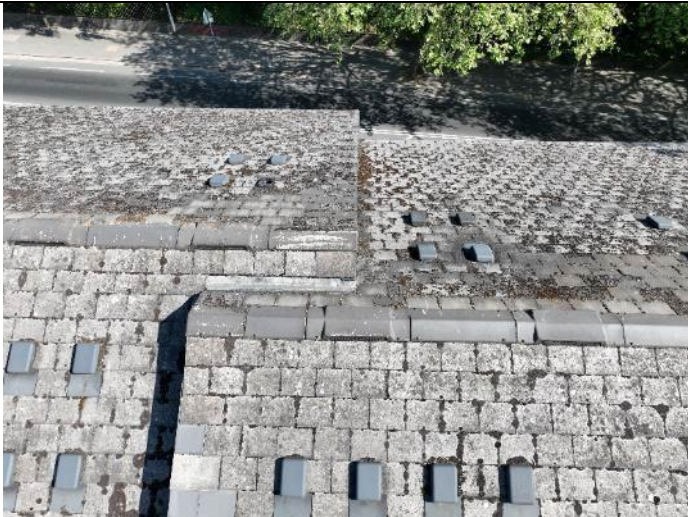
5	View of the staggered junction of the roof coverings looking down the north facing pitch.

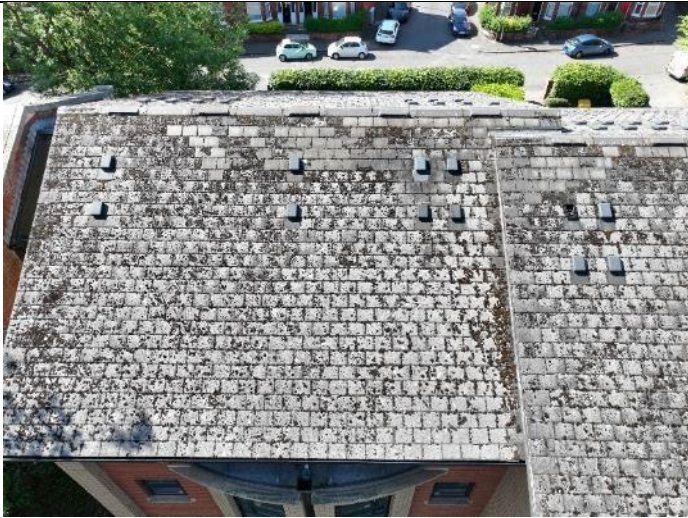
Item No.	Description	Photo
10	General view of the north facing pitch showing vegetation growth throughout.

We recommend consideration be given to cleaning the roof coverings, however it should be noted that this can cause issues of water ingress due to typical cleaning methods using pressurised water systems.

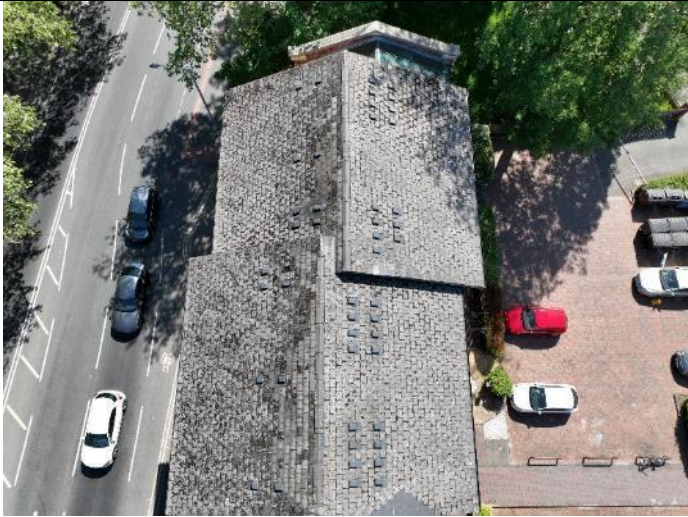
<p>An aerial photograph showing a large, flat roof covered in grey stone tiles. The roof is heavily overgrown with dark green moss and small plants, particularly in the center and towards the edges. Several small, dark rectangular objects, possibly roof vents or skylights, are visible. In the background, a street with parked cars and greenery is visible.</p>
11	General view to roof section 2 at the east end of the building.

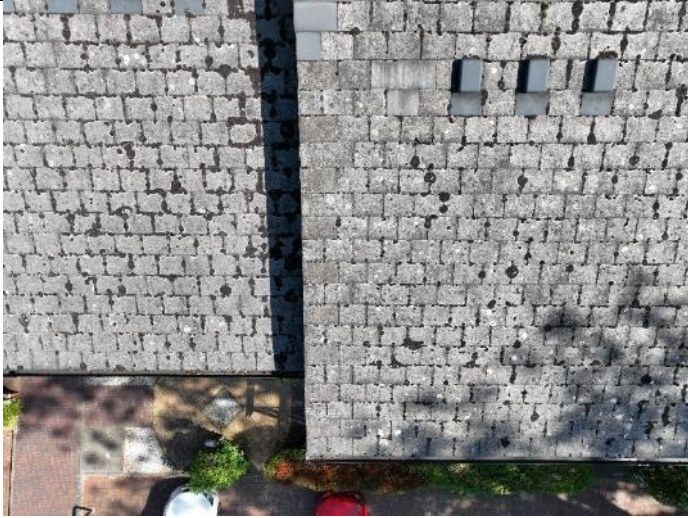
<p>An aerial photograph showing a building with a complex roof structure. The main roof is covered in grey stone tiles. A prominent feature is a stepped roof junction where a lower section meets a higher one. The building is situated on a street with several cars parked along the curb. Trees and a brick-paved area are also visible.</p>
12	General view of the stepped roof junction.

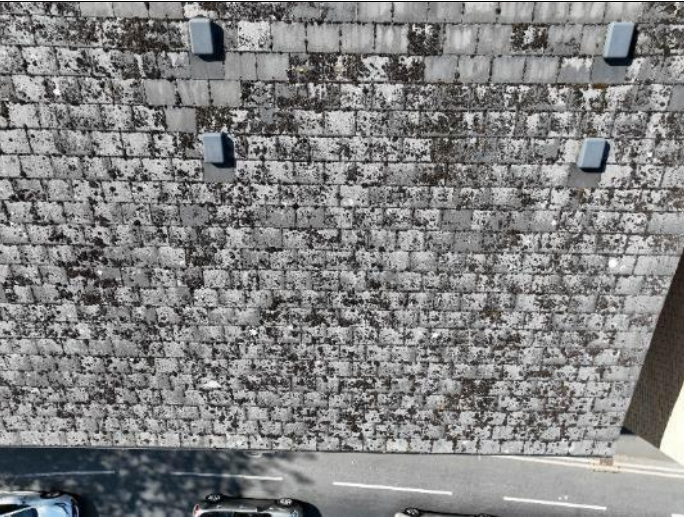
Item No.	Description	Photo
16	Further view of vegetation growth to the roof coverings.

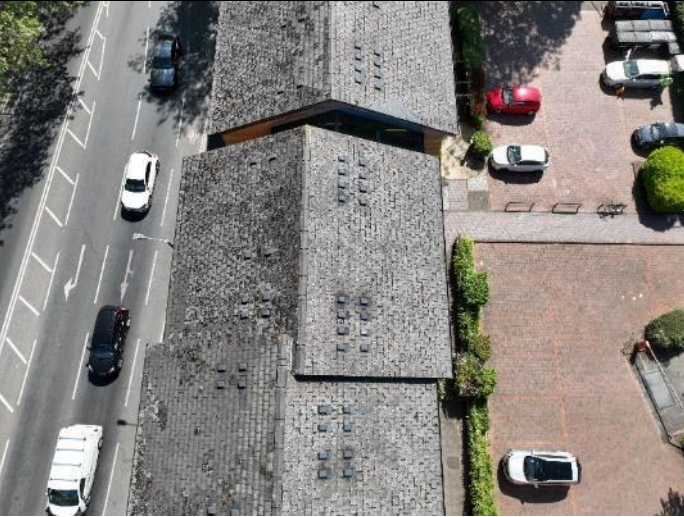
17	General view to roof section 3 at the mid-section of the east wing of the building.

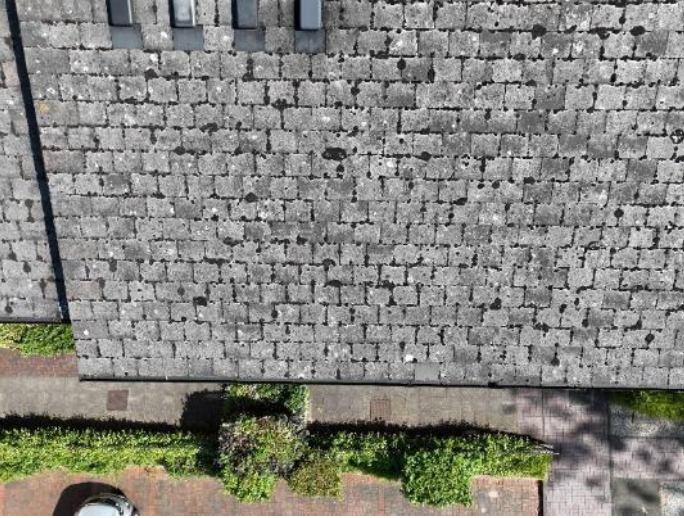
18	General view showing some vegetation growth.

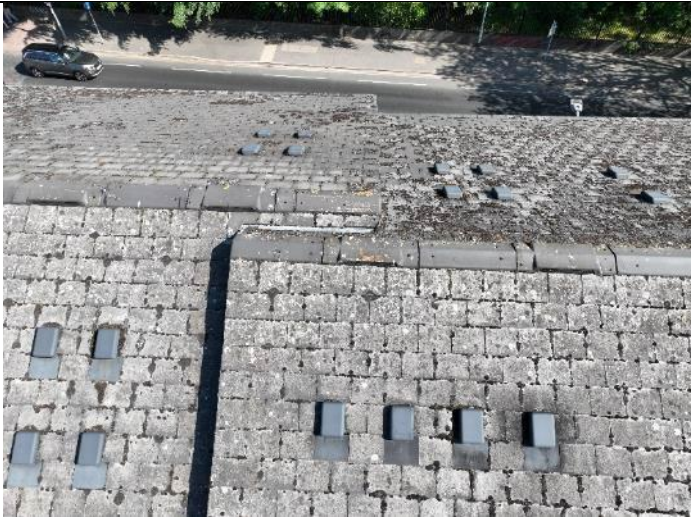
Item No.	Description	Photo
19	View towards the staggered ridge junction detail.

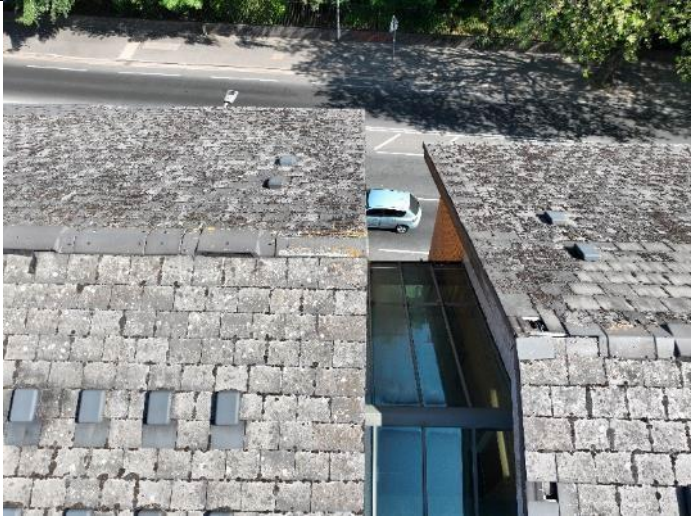
21	View along the verge detail at the junction with the glazed linked staircase.

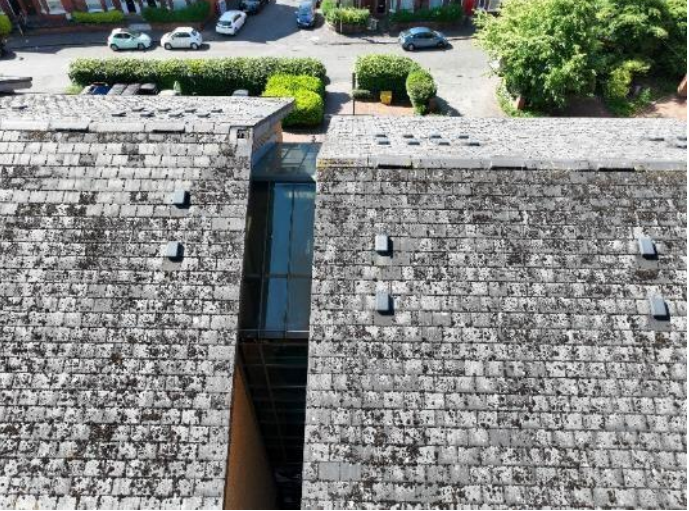
Item No.	Description	Photo
25	General view of the verge to section 3 and the interlinking glazed roof leading to section 4.

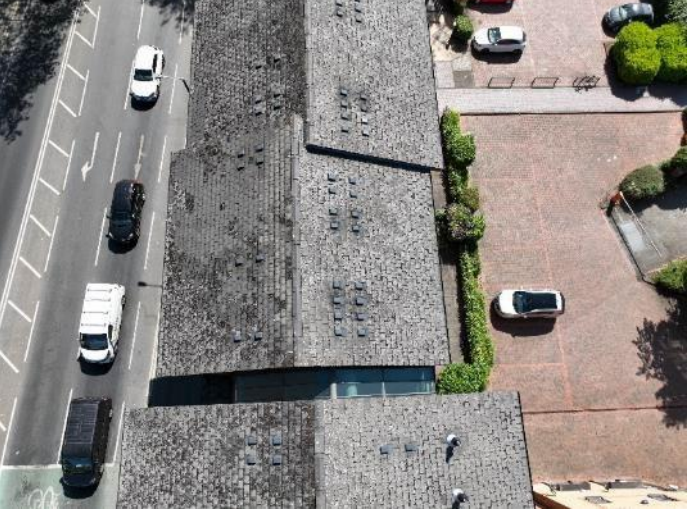
26	General view to the fourth roof section of the east section of the building.

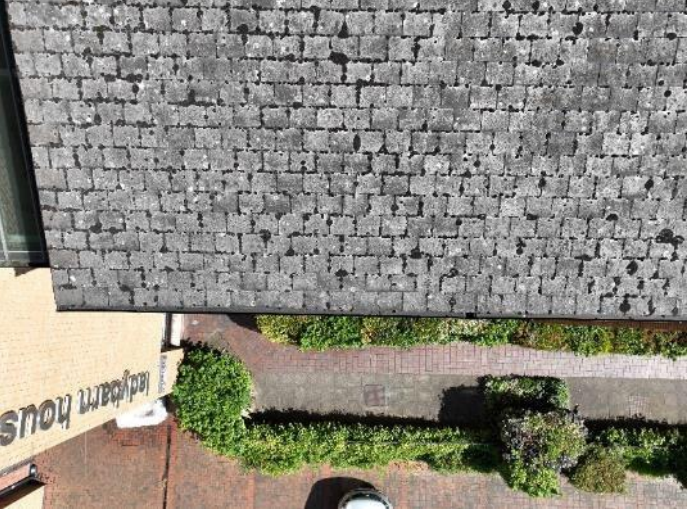
27	Minor vegetation growth to joints in the tiled covering.

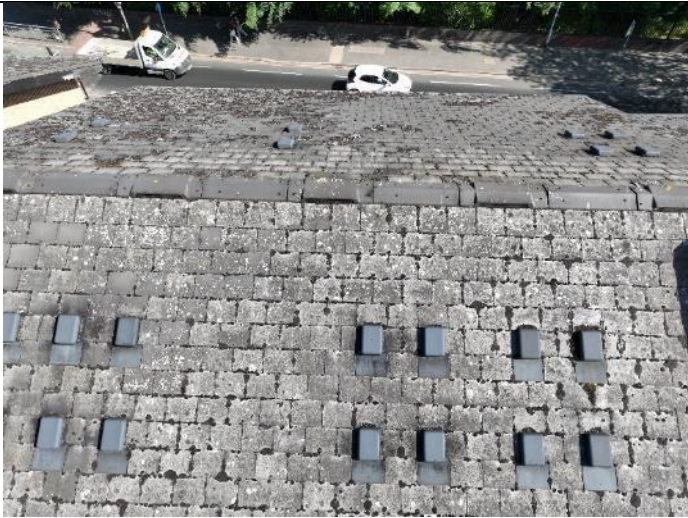
Item No.	Description	Photo
28	Vegetation growth generally to the roof coverings.

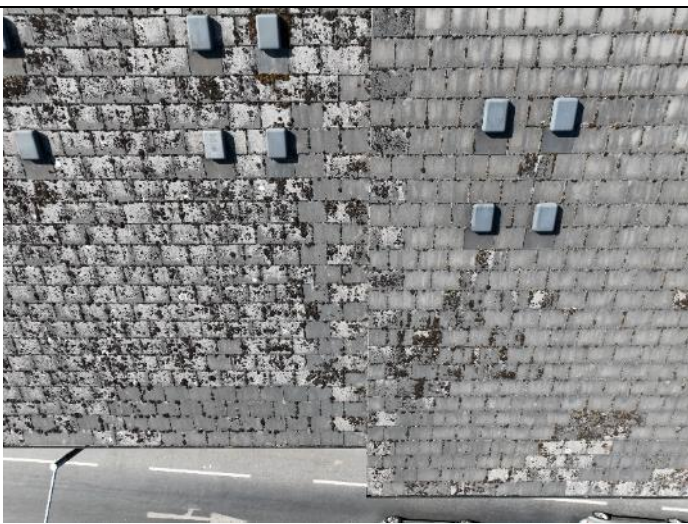
<p>An aerial photograph showing a large, flat roof covered in grey asphalt shingles. The roof is heavily overgrown with dark, dense vegetation, particularly in the central and right-hand sections. Several dark, rectangular roof vents are visible, some partially obscured by the plants. In the background, a paved street with a few parked cars and some greenery is visible.</p>
29	Vegetation growth generally to the roof coverings.

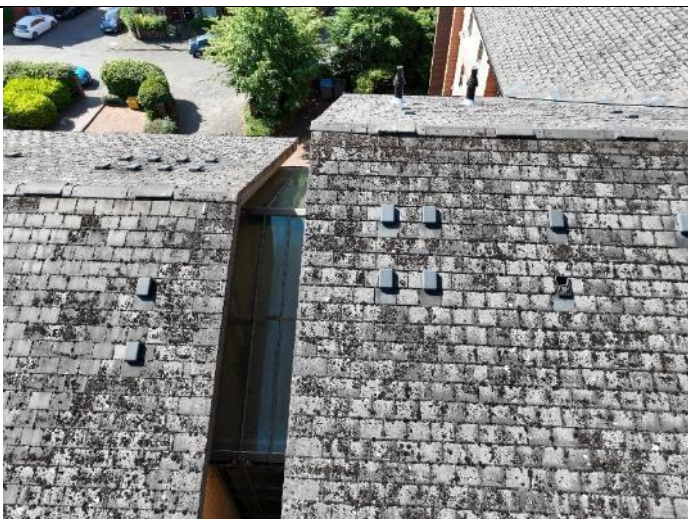
<p>A close-up aerial view of a roof section. The grey asphalt shingles are heavily covered with dark, fuzzy vegetation, likely algae or moss, which is particularly dense in the lower-left and central areas. Several dark roof vents are scattered across the roof surface. The edge of the roof meets a dark asphalt road at the bottom of the frame.</p>
30	Vegetation growth generally to the roof coverings.

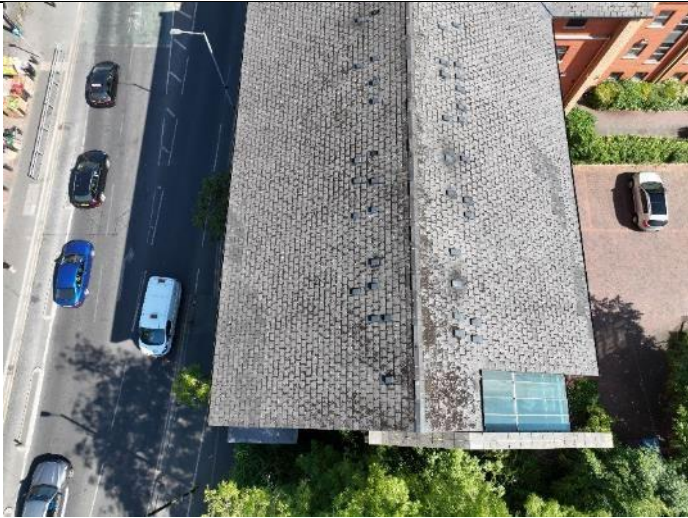
Item No.	Description	Photo
34	General view of the fifth section south wing.

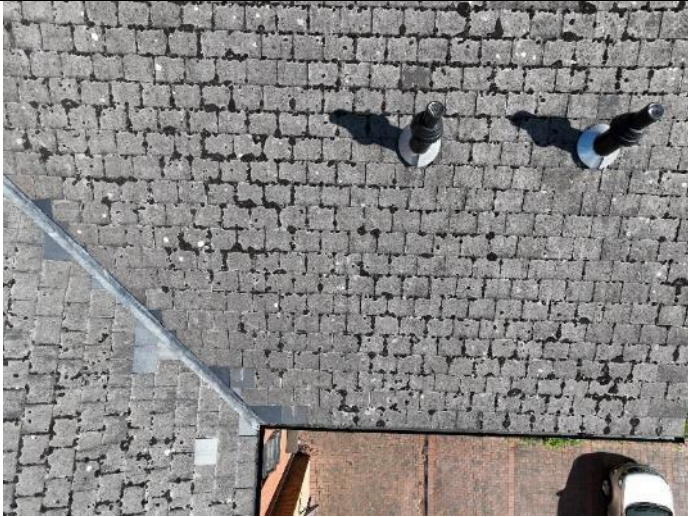
At the junction between the south and east pitches is a valley gutter presumed to be lined with lead. Adjacent to this, on both sides are new looking tiles, these have no visible fixings, or fixing holes, they are therefore presumed to be held in place with some form of adhesive. The number of replacement tiles increases towards the parapet wall of the penthouse projection, with a few of these appearing displaced.

<p>An aerial photograph showing a large, rectangular building with a grey, tiled roof. The building is situated on a street corner. Several cars are visible on the road to the left, and a white car is parked on the sidewalk to the right. The surrounding area includes trees and other buildings.</p>
35	Flues projecting through the south pitch and replacement tiles to adjacent to the valley gutter.

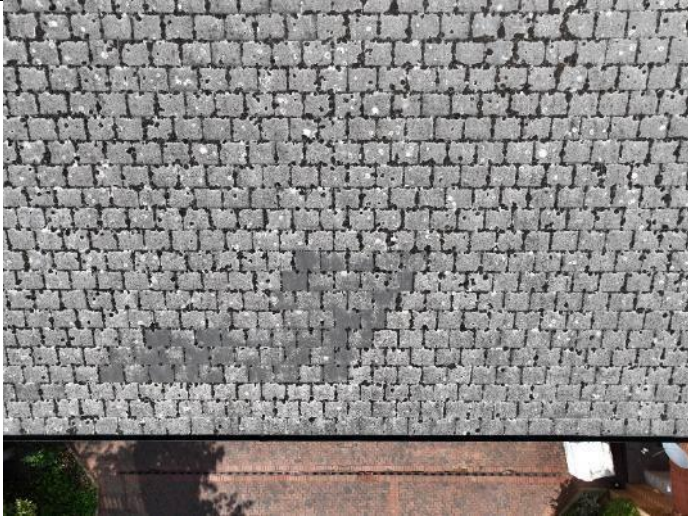
<p>A close-up aerial view of the roof tiles. Two dark, cylindrical flues are visible, protruding from the roof surface. The tiles are grey and arranged in a regular pattern. A white car is partially visible at the bottom right corner of the image.</p>
36	General vegetation growth throughout the coverings.

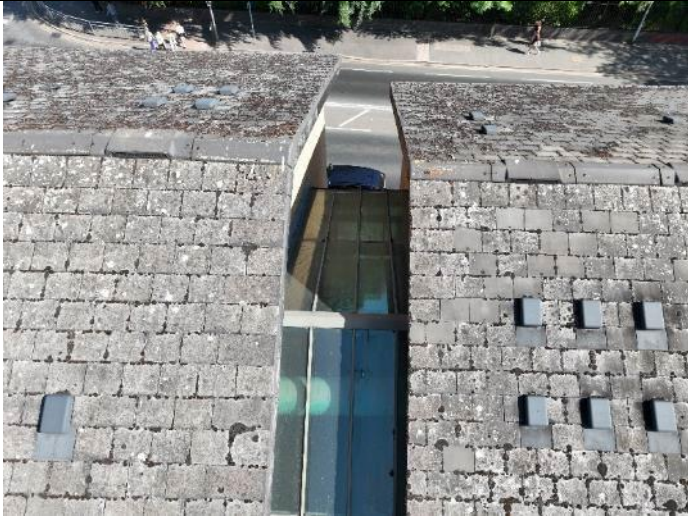
41	Vegetation growth and weathered barge boards.

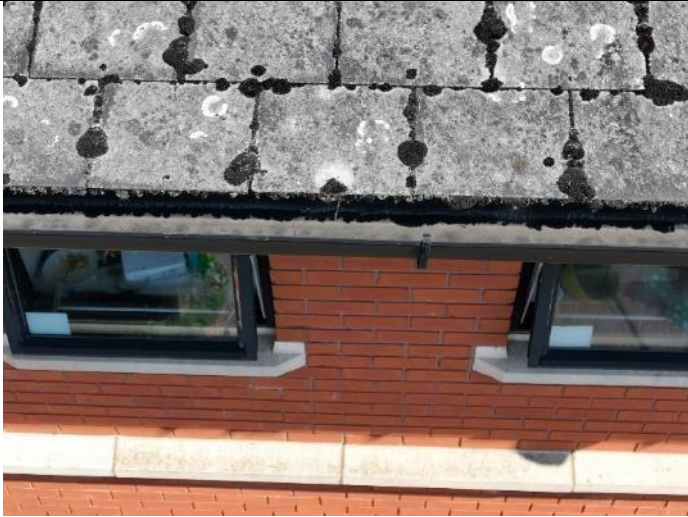
53	Clear gutters in areas, with vegetation growth to the bottom edge of the tiles

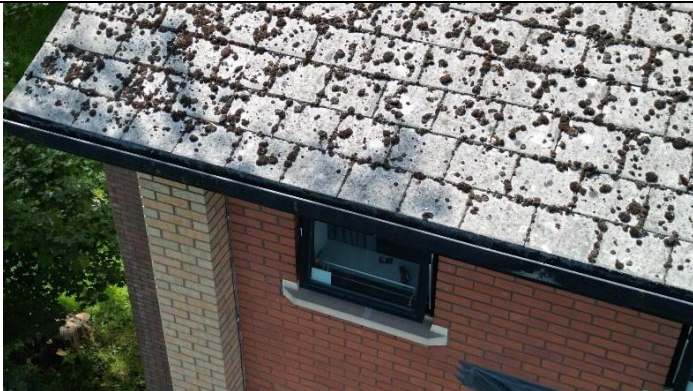
56	Minor debris to guttering on north pitch.

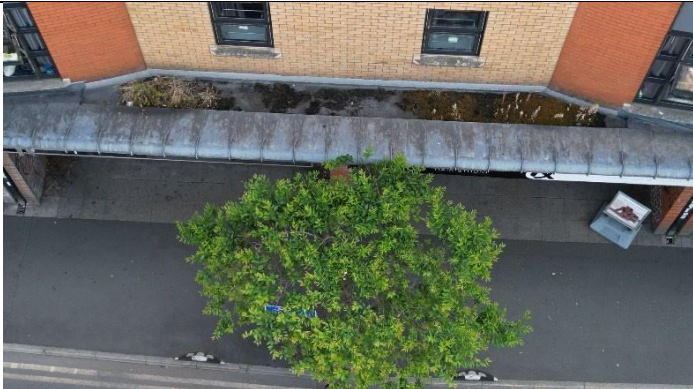
We note large areas of moss growth or moss debris from the main roof collecting on the canopy that will cause rainwater to back up and potentially overflow flashing depths and cause internal damage. Some of this is now providing soil for larger plants to start growing and will need clearing away.

Item No.	Description	Photo
70	Further vegetation growth to the canopy coverings.

We further recommend clearing all the debris from the ground floor canopy to prevent further deterioration of the coverings.

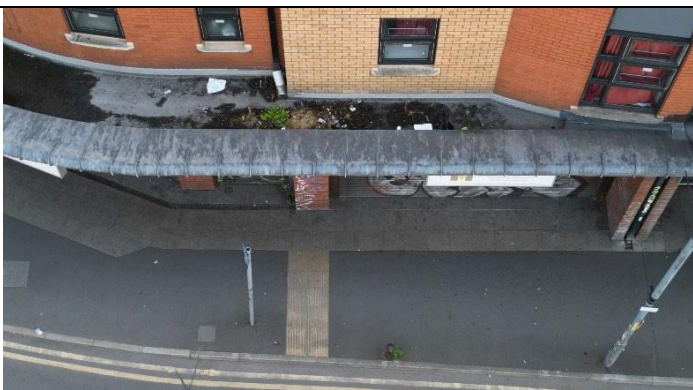
71	Vegetation growth and debris to the canopy coverings.

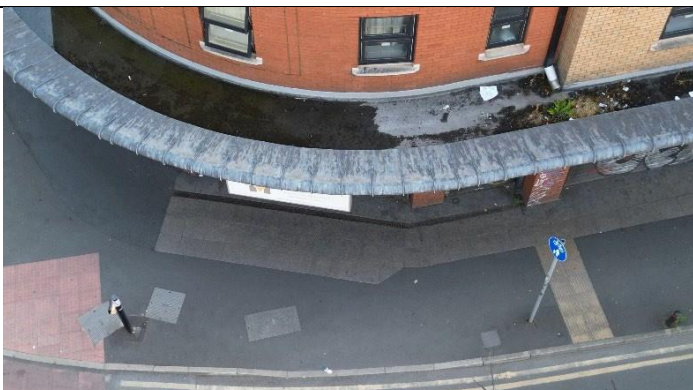
72	Standing water, debris and vegetation growth to the canopy coverings.
